**CONOCOPHILLIPS COMPANY ("CONOCOPHILLIPS"),
ON BEHALF OF PHILLIPS PETROLEUM COMPANY,
TOSCO CORPORATION AND ASSETS OF 76 PRODUCTS COMPANY**

**RESPONSES TO JANUARY 18, 2008
EPA FIRST REQUEST FOR INFORMATION
PORTLAND HARBOR SUPERFUND SITE
PORTLAND, OREGON**

**RE: Upland Storm Water Source Control Status Report
ConocoPhillips Company – Portland Terminal
5528 NW Doane Avenue
Portland, Oregon**

RE: **Doane Avenue Storm Sewer
Video Survey Summary
Willbridge Bulk Fuel Terminals
NW Doane Avenue
Portland, Oregon**

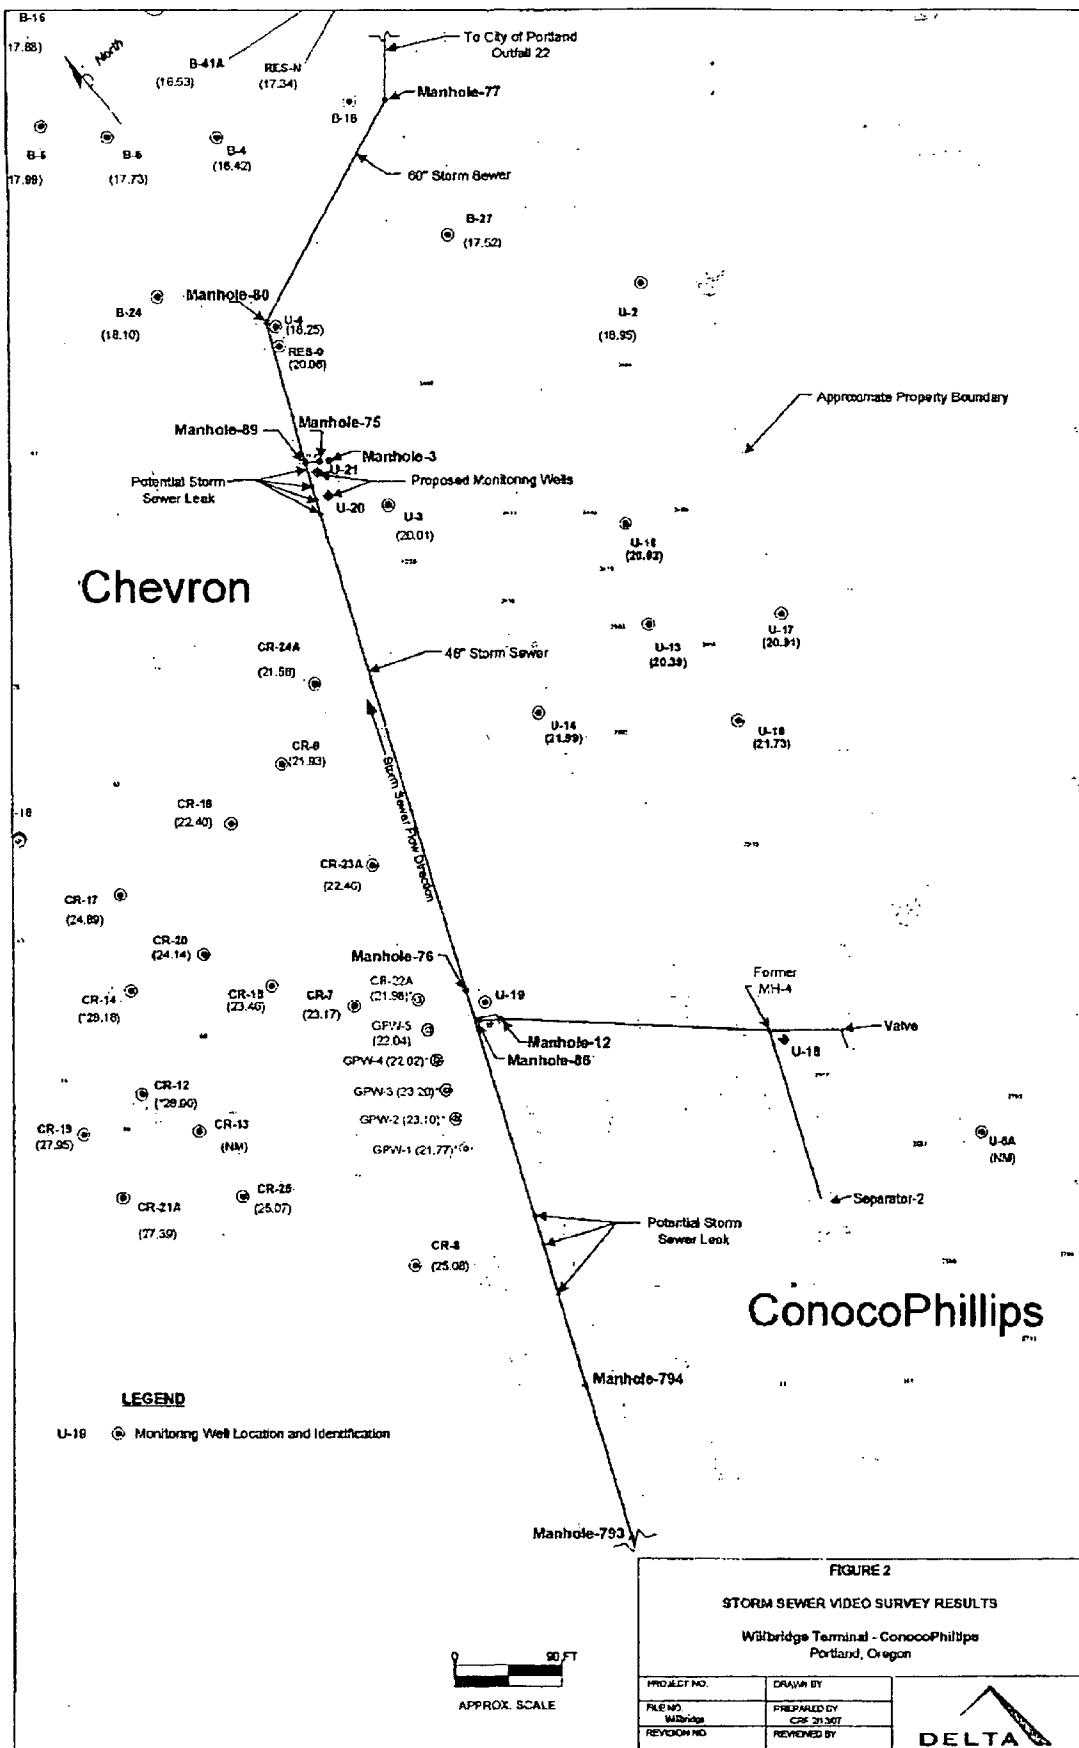
- Figure 1 – Site Location Map
- Figure 2 – Storm Sewer Video Survey Results

Delta subcontracted Cowlitz Clean Sweep (CCS) to conduct the video tape survey of the 48-inch storm sewer under Doane Avenue on February 7, 2007. The descriptions below are the observations made during the survey and are also described on CCS field log included as Attachment A. A copy of the video tape is provided on the enclosed DVD. Leaky storm water pipe joint locations observed during the video survey are shown on Figure 2.

The camera was lowered into MH-86 and slowly moved down the 48-inch storm sewer down stream towards MH-80. At 1.3 feet from MH-86, a lateral line from the right (discharge from MH-12 lateral) entered the 48-inch storm sewer line. Most notable was a large mat of iron precipitation descending from the lateral and a few dark liquid droplets were noted along the edges of the iron precipitation mat. Due to the height of the lateral above the bottom of the storm sewer, viewing by the camera inside the lateral was not possible. The camera was moved down stream to 24 feet without any notable leaky joints. At 25.6 feet the camera went underneath MH-76. The bottom side of an intersecting process sanitary sewer line was viewed and appeared to be in good condition. Some dark staining was noted but no evidence of active leaking was apparent. The camera then moved past MH-76 towards MH-89. At 131.8 feet, 143.7 feet, and 167.6 feet; joints in the 48-inch storm sewer line were stained dark. Possible repairs areas (concrete patches) were noted at 274.5 feet and 394.4 feet but no leaking or staining was observed. At 431 feet, 443 feet, and 455 feet; pipe joints showed indications of leaking by the observed mats of iron precipitation and dark liquid droplets but no sheen was observed at these joints. Sheen was observed coming from the bottom of the pipe joint at 467.1 feet. At 472.1 feet the camera went beneath manhole MH-89. Iron precipitation was observed in and around the area beneath the ladder rungs. A lateral from MH-75 (camera right) entered the 48-inch storm sewer line at 475.2 feet. Dark staining was noted in and underneath the pipe lateral. The lateral intersected the 48-inch storm sewer line above camera level so viewing into the line was not possible. Very little iron precipitation was present at this lateral. Directly across the 48-inch storm sewer line (camera left), a lateral from the Chevron terminal was present and noted as having large amounts of iron precipitation. The Chevron lateral intersected the 48-inch storm sewer line above camera level so viewing into the line was not possible. At 583.9 feet the camera approached MH-80. A flow meter installed by the City of Portland was present at MH-80 and the 48-inch storm sewer pipe begins to sweep to the cameras right and travels beneath Front Avenue. No leaky joints were noted at MH-80 and the camera was pulled back to MH-86 and removed from the storm sewer.

Visible sheen was noted looking down into the storm sewer from MH-76 prior to lowering the camera into the manhole. The camera was placed in MH-76 and directed upstream towards MH-794. No sheen was visible in the vicinity of MH-76 from the cameras view point. At 20.9ft the lateral from MH-12(camera left) is observed. Iron precipitate mat and some dark liquid droplets were visible. At 27 feet the camera passed manhole MH-86. At 192.7 feet a lateral (camera right) from the Chevron terminal enters the 48-inch storm sewer line. Iron precipitation and dark staining was observed coming from and beneath the lateral pipe. At 217.1 feet a former lateral (camera right) was observed. It appeared that the lateral line was plugged and/or decommissioned. Dark staining and orange tinge were noted to be present but not fresh or wet in appearance. At 259.4 feet a leaky joint was observed. No iron precipitation was observed but heavy, dark, wet staining was present. Large cobble were encountered around the leaky joint and at 286.7 feet. Beyond this joint more large cobbles prevented further camera travel toward MH-794. The camera was stopped approximately 50 feet down stream of MH-794.

On February 8, 2007, Delta subcontracted CCS to plug the lateral at MH-75 that is connected to the 48-inch storm sewer near MH-85. The lateral was plugged at the 48-inch storm sewer and at MH-75. Prior to plugging the lateral the City's maintenance office was contacted and approval was granted to enter the storm sewer to plug the lateral. Storm water from the COP tank farm is presently being pumped into MH-85 from MH-3. This will continue until the lateral is lined to prevent infiltration of groundwater and sheen.

Presently the valve is closed at MH-12 and sorbent pads are in the manhole. Delta has contacted a subcontractor to line in place approximately 200 feet of 10-inch pipe from the oil/water separator 002 to the former manhole MH-4 at the COP terminal to prevent infiltration of groundwater. Storm water will not be discharged through MH-12 until the 10-inch pipe is lined. COP also has plans to seal MH-12 and line in place the lateral to the 48-inch storm sewer from MH-12. Lining of the pipes on COP property, sealing MH-12 and lining the laterals at MH-12 and MH-79 is tentatively scheduled for late March or early April 2007.

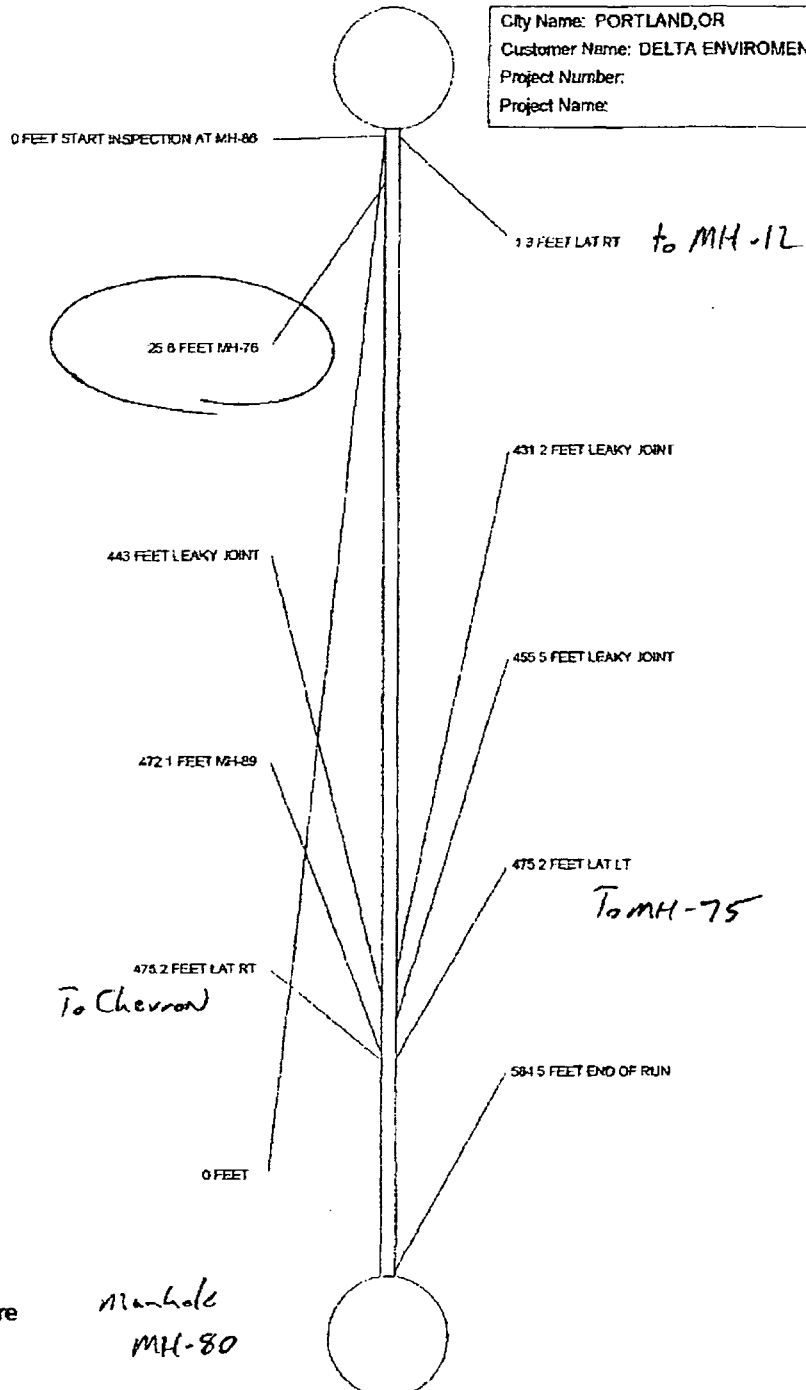
Upstream Structure
MH-86

Distance	Code	Clock	Priority	Parameters	VCR Cnt	Image	Comments
0	GO						START INSPECTION AT MH-86
1.3							LAT RT <i>to MH-12</i>
25.6							MH-76
431.2							LEAKY JOINT
443							LEAKY JOINT
455.5							LEAKY JOINT
472.1							MH-89
475.2							LAT LT <i>to MH-75</i>
475.2							LAT RT <i>Chenal</i>
584.5							END OF RUN <i>MH-80</i>

Sheen observed at 467.1 after review tape
AP

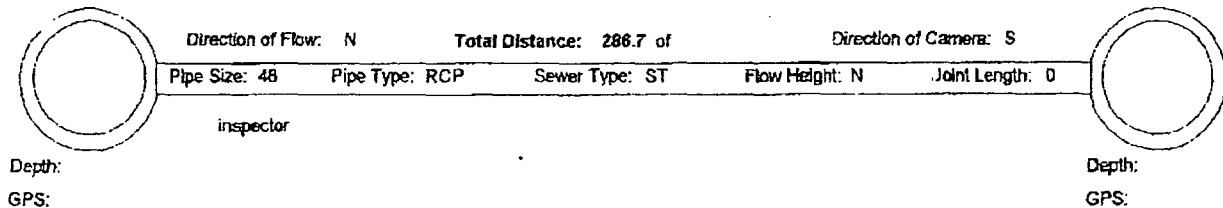
Upstream Manhole
MH-76

Distance	Code	Clock	Priority	Parameters	VCR Cnt	Image	Comments
8	GO						START INSPECTION AT MH-86
20.9							LAT LT
27							MH-86
192.7							LAT RT CHEVRON
217.1							LAT RT
259.4							LEAKY JOINT
286.7							END OF RUN
